ROYAL AIRCRAFT ESTABLISHMENT

Technical Report 81127

SOME FUNDAMENTAL ASPECTS OF COMPOSITES FRACTOGRAPHY .

D. Purslow

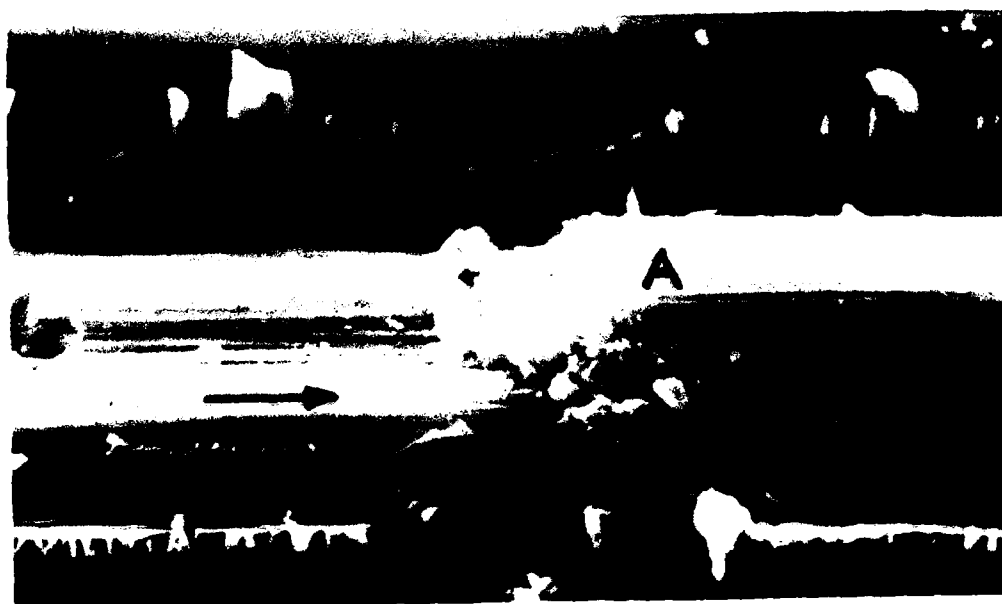
Fig 6 Shear failure (x2500)

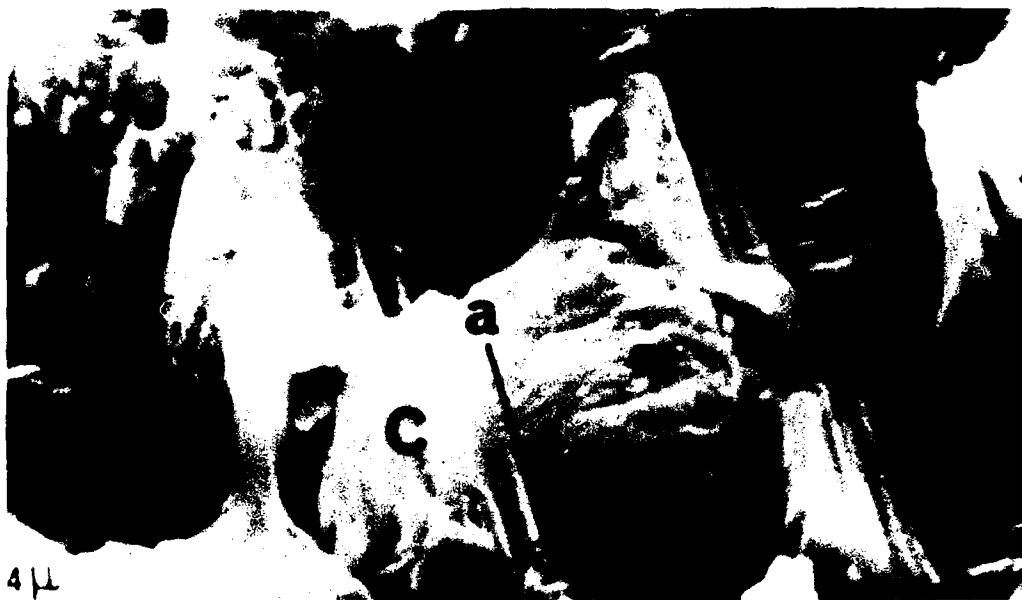
Fig 9 Compression micro-buckling (x4000)
